FOREST CITY REGIONAL SCHOOL DISTRICT

FACILITY PLANNING STUDY 2024

IMPROVEMENTS SUMMARY Forest City Regional School District

September 10, 2024

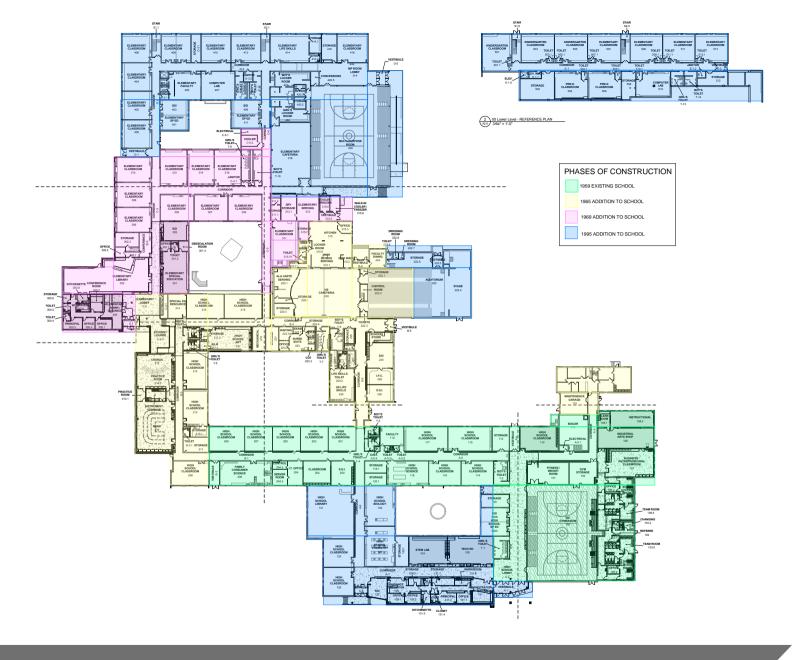
PHASES OF CONSTRUCTION FOREST CITY, PENNYSLVANIA

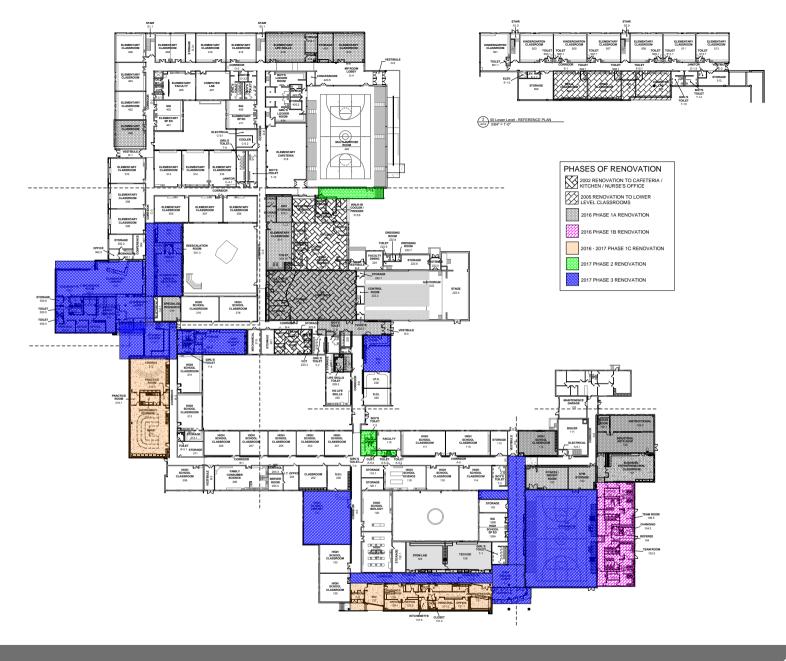
PHASES OF RENOVATION FOREST CITY, PENNYSLVANIA

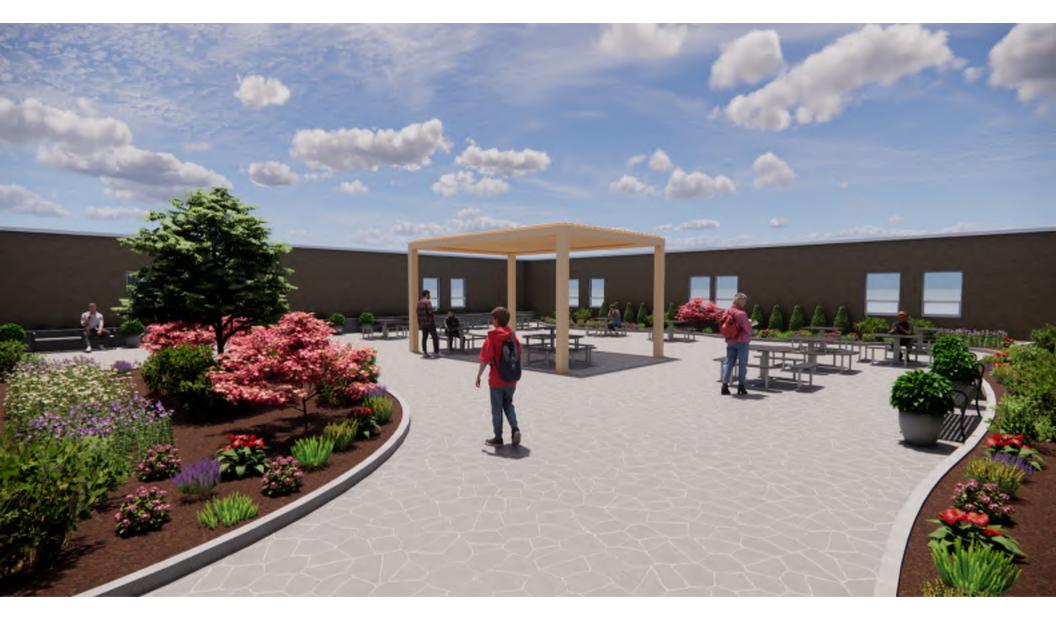
MIDDLE SCHOOL COURTYARD RENOVATION

(2) Courtyards A & B			\$75,000	Courtyard upgrade cost will vary depending on the number of courtyards improved and the level of the improvements. The extent of pavement / hard surface, landscaping, furniture and shade structures will determine the final costs. The cost range is projected at \$40,000 to \$150,000. We included \$75,000 in the cost		
	Cosmetic upgrade to classrooms			\$50,000	The Classrooms are well maintained and for the most part in good condition. There are some minor finish work and casework that should be repaired but they do not require a full upgrade. A full upgrade would include new floor, wall and ceiling finishes. Also, with the ceiling new LED lighting would be installed. The cost included in the summary is intended to cover the minimal scope. Full scope would be in the \$25,000 per classroom		
	Cosmetic upgrade to corridors			\$35,000	Similar to the classrooms, the corridors are well maintained. Minimal work is projected and included in the report.

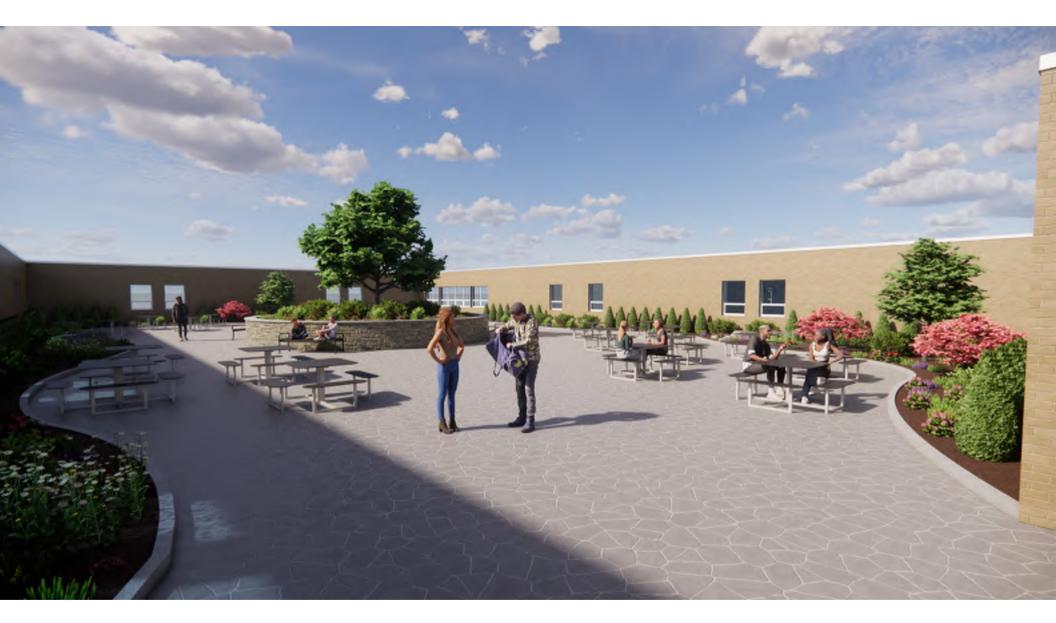
HIGH SCHOOL COURTYARD RENOVATION

Recommendations and Cost						
Evalua	Anticipated Replacement					
System / Subsystem	Component	Short Term	Mid Term	Long Term	Comments	
General Construction						
Interio	· Auditorium		\$600,000		Front curtain track, projector screen, house & theatrical lighting, water damage / leaking below grade along plan	
	Control Room		\$4,000		Replace flooring	
	Drama Storage			\$10,000	Replace ACT	
	Cafeteria	\$1,500			Replace missing & damaged vinyl wall base, Ala Carte underutilized	
	Kitchen		\$250,000		Dishwasher & Steamers function but is past useful lifespan, replace missing and damaged wall base	
	Locker Pooms / Toilet Pooms		\$75,000		Address tile failure issue	
	Locker Rooms / Toilet Rooms (2) Courtyards C & D		Ψ13,000	\$75,000	Courtyard upgrade cost will vary depending on the number of courtyards improved and the level of the improvements. The extent of pavement / hard surface, landscaping, furniture and shade structures will determine the final costs. The cost range is projected at \$40,000 to \$150,000. We included \$75,000 in the cost

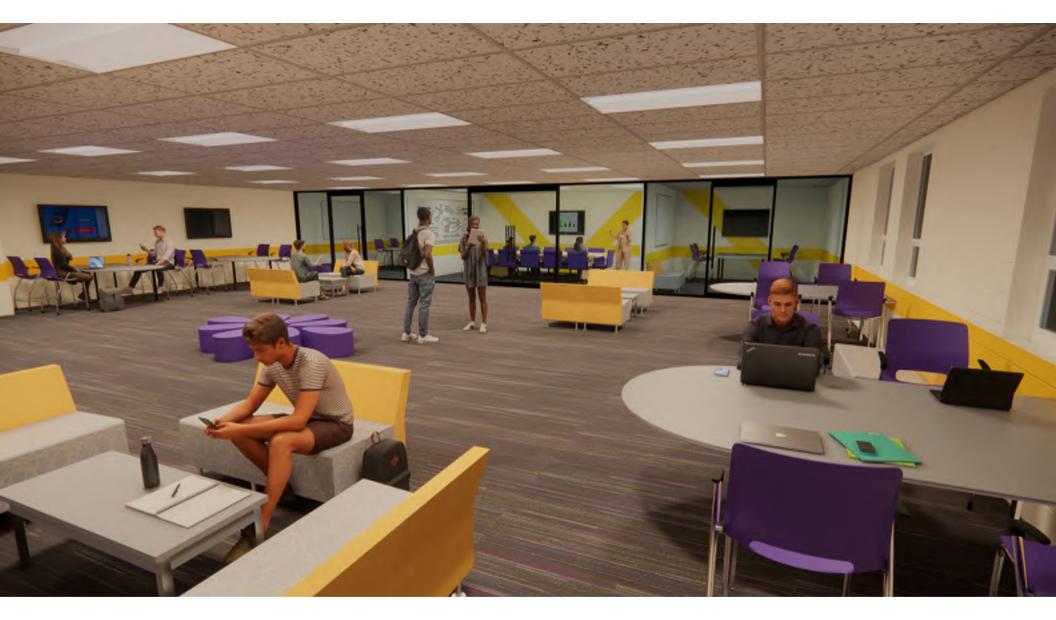
HIGH SCHOOL LIBRARY FOCUS BOOTHS RENOVATION

Library -121			\$200,000	The vision for the library is to create a new modern space that promotes learning and digital opportunities for the students. Work areas will vary from individual to small / mid size groups. In addition the space could be configured for faculty instruction and board meetings. Costs will vary based on final design and technology included. Budget number included will vary	
	Classroom 213		\$10,000		Replace flooring	
	Gym 100		Ψ10,000	\$125,000	Basket height adjustment, includes replacement.	
	Classroom 206 (former FCS)			\$75,000	More efficient storage	
	Vestibule B-8 Entry doors are too small		\$40,000		Principal noted the door is used for building loading and unloading.	
	Cosmetic upgrade to classrooms			\$70,000	The Classrooms are well maintained and for the most part, in good condition. There are some minor finish work and casework that should be repaired but they do not require a full upgrade. A full upgrade would include new floor, wall and ceiling finishes. Also, with the ceiling new LED lighting would be installed. The cost included in the summary is intended to cover the minimal scope. Full scope would be in the \$25,000 per
